**8. Swift Avenue**

**B. Office/Hangar:**

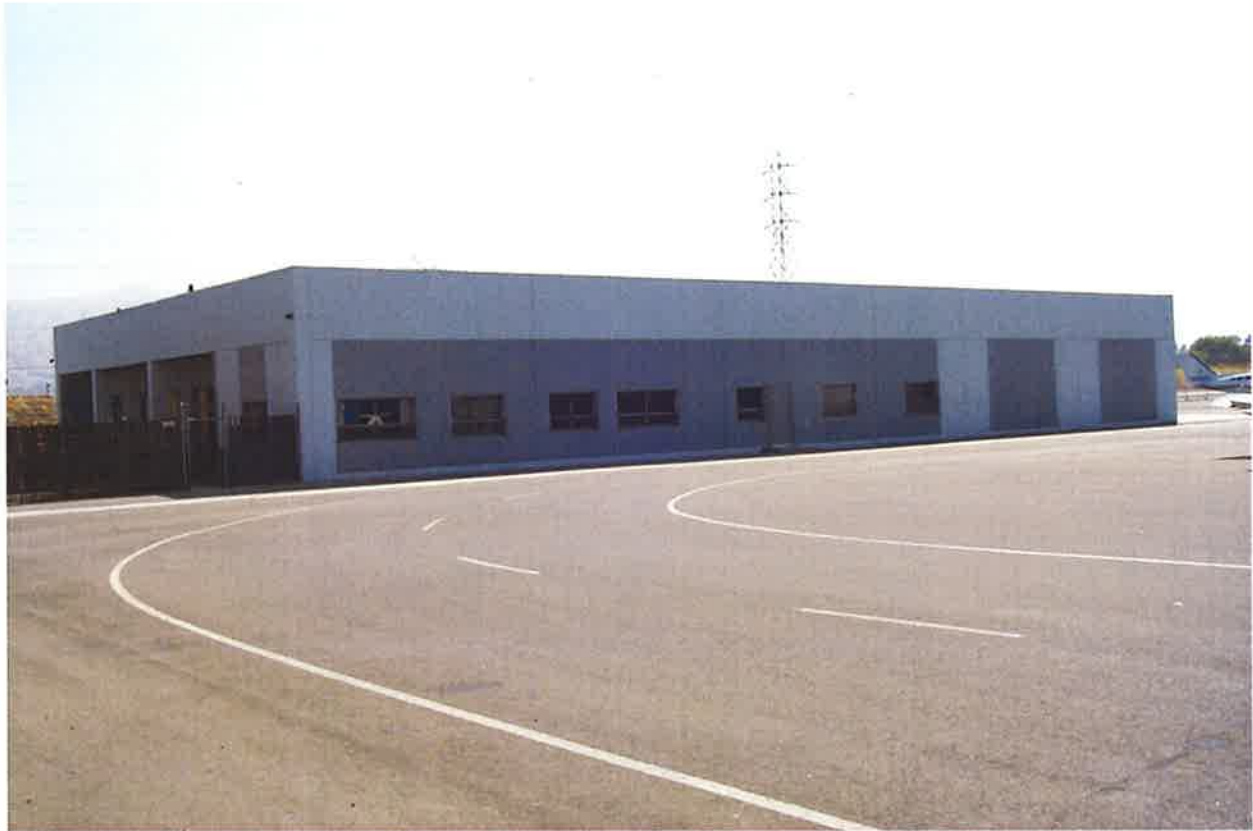
- a. The Office/Hangar building is a single-story concrete tilt-up structure with an area of 10,880 square feet. The original structure was built in 1977. The building houses offices, conference room, staff lunchroom, restrooms, and utility rooms in the north portion of the building. The south portion of the building is an aircraft hangar and a small single occupant, gender-neutral toilet room.
